ATLANTIC COAST BASIN
MULLICA RIVER, BURLINGTON COUNTY
NEW JERSEY

ATSION LAKE DAM

NJ 00041

**PHASE 1 INSPECTION REPORT
NATIONAL DAM SAFETY PROGRAM**

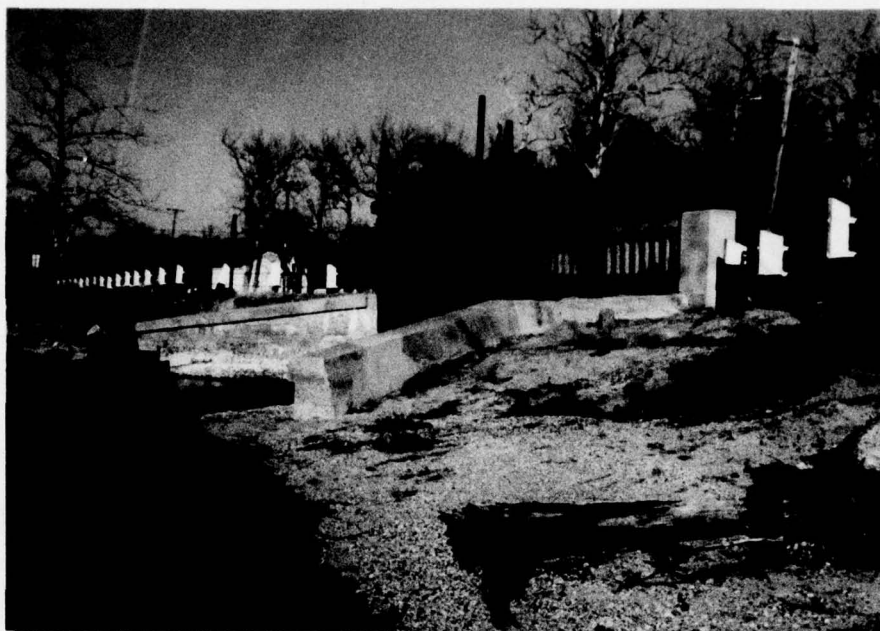
PHOTO 1

Steel sheet piling along the upstream face of embankment on either side of the spillway appeared to be structurally sound but its surfaces are severely rusted.

SPILLWAY APPROACH CHANNEL.
RUSTED STEEL SHEET PILING.

5. Thoroughly inspect the steel sheet piling and take any necessary remedial action. Construct a concrete cap on the upper portion of the sheet piling to restore the conditions of 1942 at which time the N.J. Highway Department reportedly installed a concrete cap.

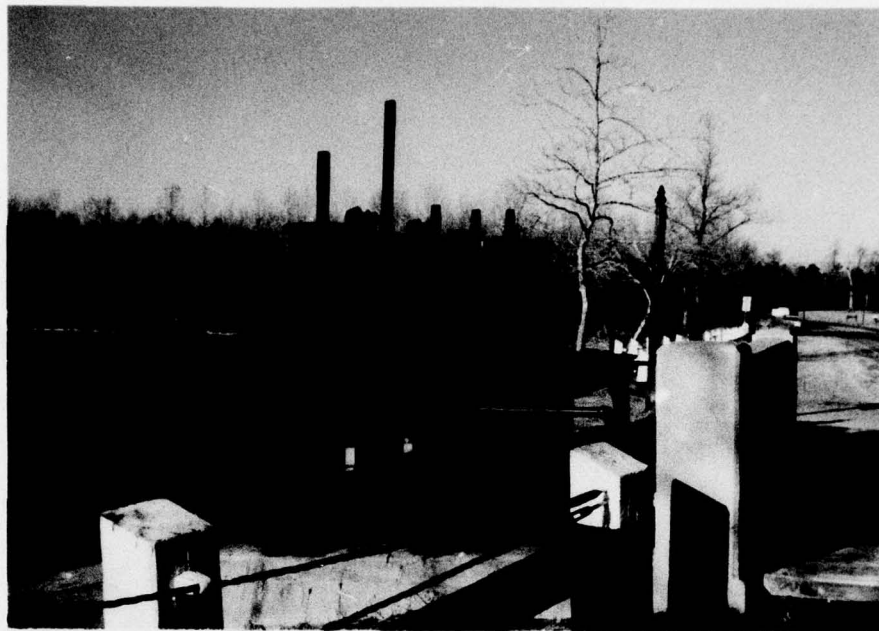
PHOTO 3

GATE OPERATING MECHANISM AND
TIMBER WALKWAY

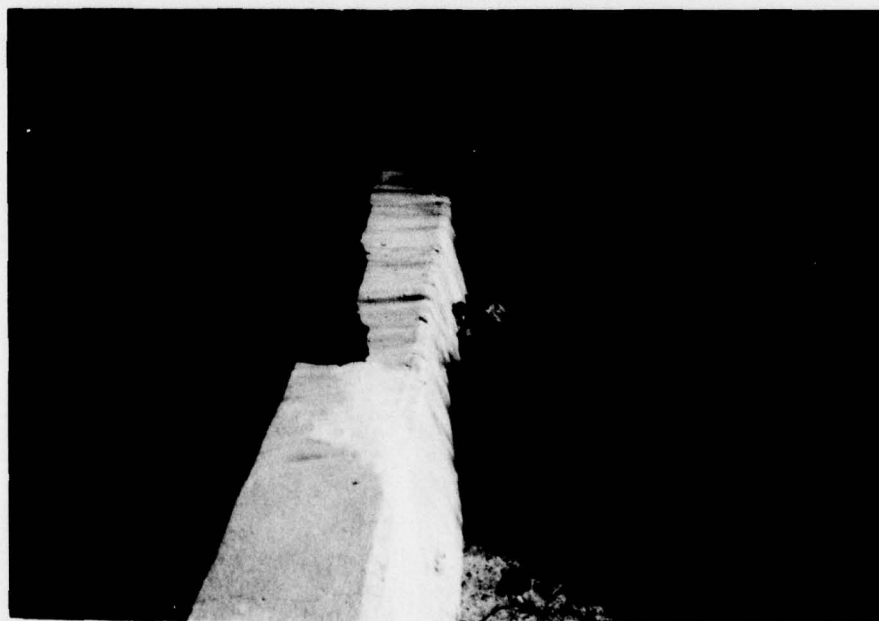
PHOTO 6

The concrete bridge, although appearing structurally sound, contains a significant number of cracks and spalls which should be repaired in the near future by sand blasting, grouting where needed and coating with epoxy.

BROKEN CONCRETE IN DOWNSTREAM
WINGWALL OF BRIDGE

- a. Drain the lake to an elevation equal to the bottom of the gates.
 - b. Sand blast all concrete and pressure grout all major cracks and patch spalls and eroded surfaces.

- c. Apply an epoxy preservative coating to all surfaces.
3. Repair or replace the timber slide gates.
4. Fill and compact all eroded surfaces of the embankment and restore a suitable grass cover to all surfaces.

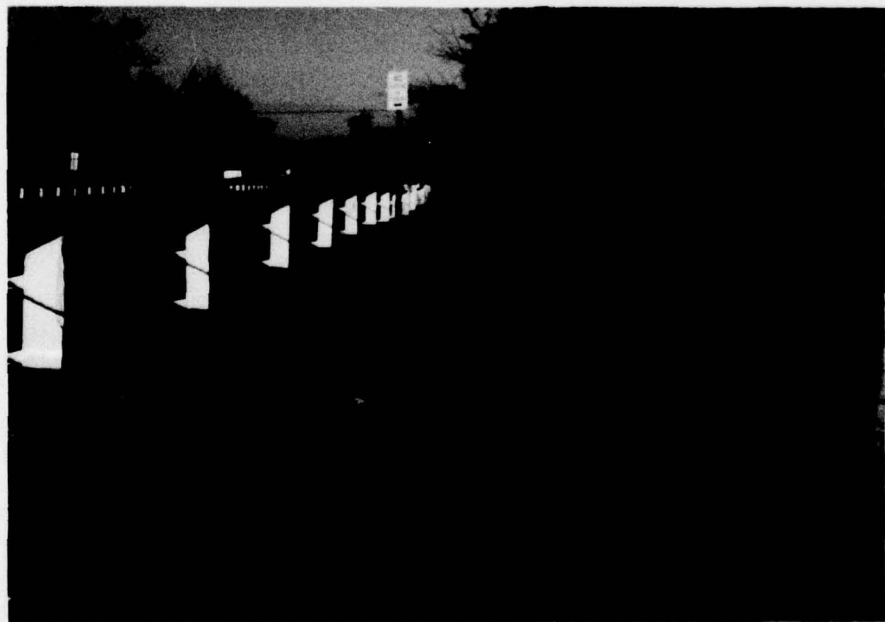
PHOTO 8

The embankment is free of settlement and appears to be structurally sound. However, trees and brush as well as erosion are present on its surface. These conditions should be repaired in the near future and thereafter maintained. Repairs include the removal of trees and brush, the filling of eroded areas and the establishment of a grass cover.

EROSION ON DOWNSTREAM FACE OF EMBANKMENT

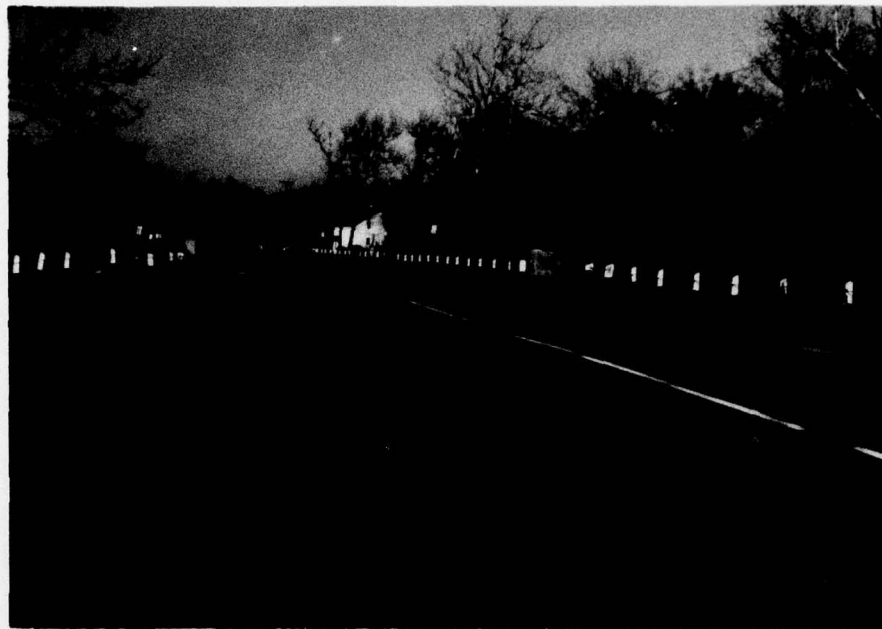
PHOTO 9

PAVED ROAD ON CREST OF DAM

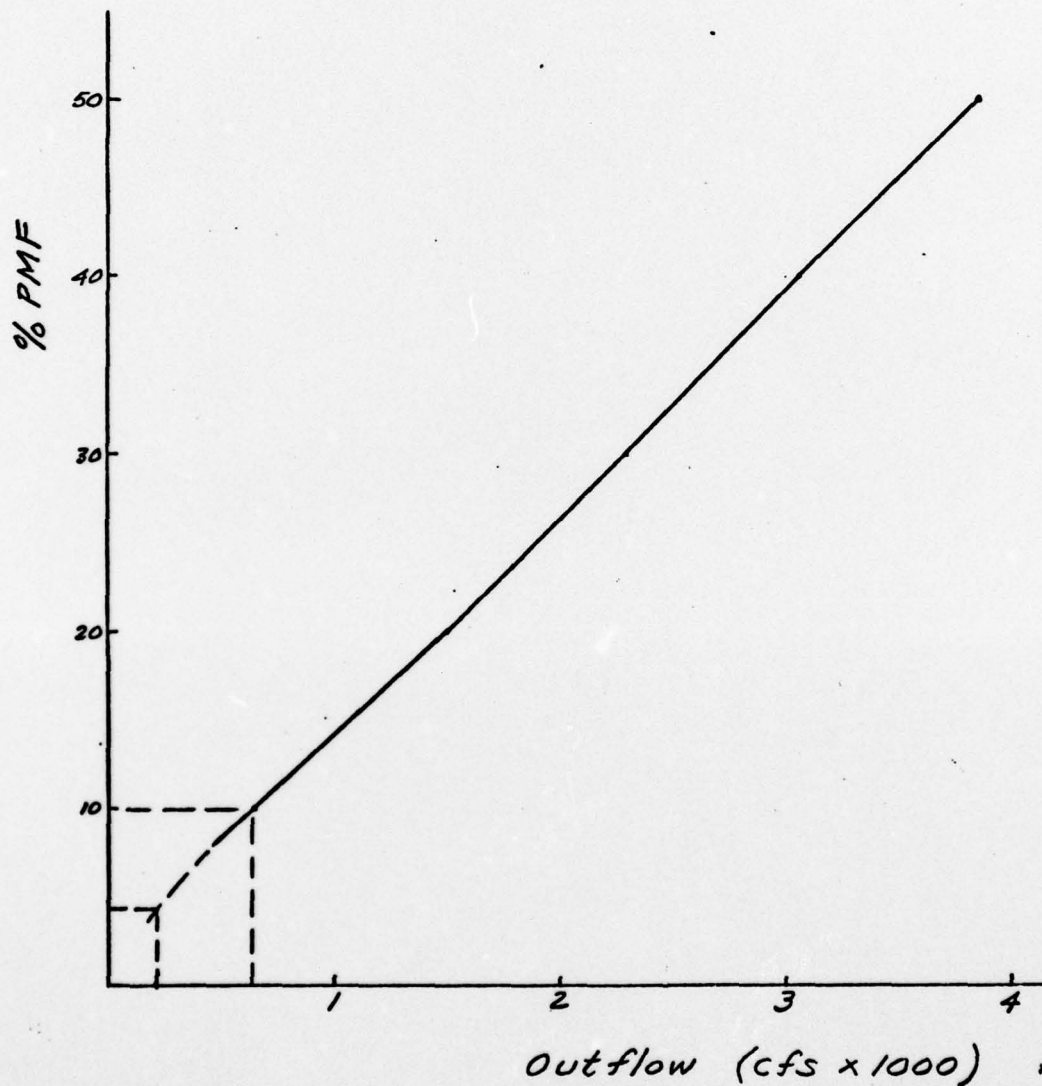
OVERTOPPING POTENTIAL

Overtopping of low area occurs at elev. 50.2
with $Q = 220$ c.f.s. ($\sim 4\%$ PMF)

Overtopping of dam occurs at elev. 50.5
with $Q = 445$ c.f.s. ($\sim 10\%$ PMF)
